North American Society for Trenchless Technology (NASTT)
No-Dig Show 2011

Paper E-5-03

ESTABLISHING OBJECTIVE TEST PROTOCOLS FOR THE QUANTIFICATION OF WATER-TIGHTNESS OF A REHABILITATED MAIN/LATERAL SEWER CONNECTION

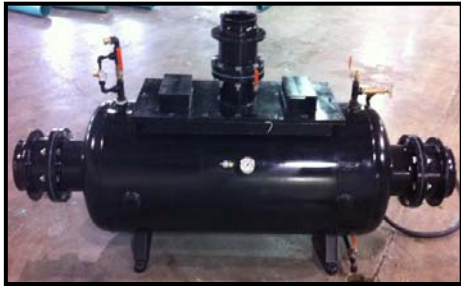
Figure 2: Hydrostatic Test Tank
(as built)

Taking the baseline, multiplication factor, and the design criteria outlined above into account, the hydrostatic test tank was built.

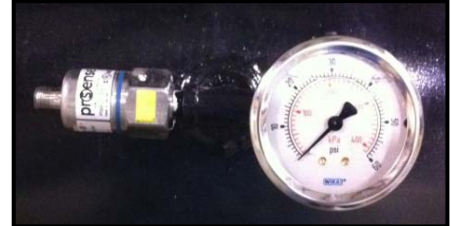
Figure 4: Pressure gauge and
transducer

- 3) Capable of allowing for the non-destructive testing of a restrained sample of the lined connection;
- 4) Capable of regulating the pressure exerted on the connection being tested (figure 3); and
- 5) Capable of real-time monitoring of pressure (figure 4)
- 6) Capable of allowing for unobstructed installation of all known rehabilitation techniques.
