Chicago, Illinois  
May 2-7, 2010

Paper B-3-04

## LOCAL ORDINANCES DICTATE LATERAL RENEWAL TECHNOLOGIES

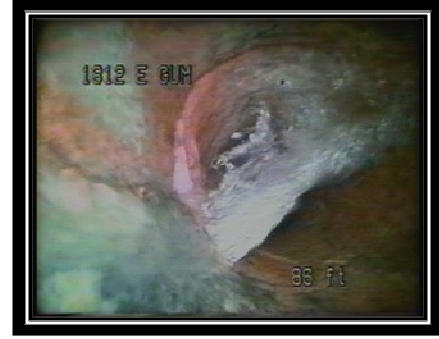
Figure 1: Leaking Lateral Pipe

The objective of lateral renewal is to seal leaking pipes and renew structural integrity. Excessive leakage occurs in manholes, the main sewer, lateral pipes and the associated connections. Ownership issues frequently arise when leakage is identified in a lateral pipe, and the question then becomes, who is financial obligated for repairing or renewing the pipe? The US Environmental Protection Agency stated, “the effectiveness of I/I removal efforts may be limited in many collection systems if private sources of I/I are not addressed”. Simpson 2005 Refer to Fig. 1

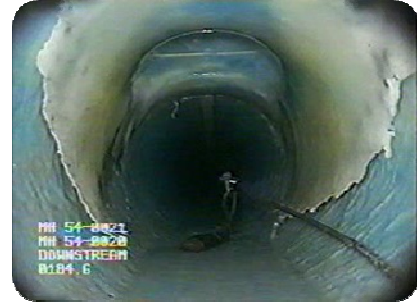
Figure 2: Failed Glued Patch

CIPP Connection Seals between the main sewer and the lateral pipe, for the most part have been a glue-in-place “hat style patch” of fabric and thermo-set resin placed at the main to lateral connection which attempt adhere to the mainline pipe upon curing of the patch. These connection seals are intended to stop water that leaks behind mainline linings and re-enters the collection system at lateral connections. However, these glue-in-place connection seals must be installed on an extremely well prepared surface. Improper preparation has limited the success of connection sealing. Three (3) major design issues have been identified that make these “hat style patch” connection seals difficult to install and permanently adhere which makes it difficult for them to remain in place after installation: Refer to Fig. 2

- The glue-in-place hat style patches offer no design parameters for determining bond strength or the ability to withstand hydrostatic loading from the ground water table rising above the crown of the pipe. This is due to the lack of cylindrical shape and sole dependence on adhering to the host pipe. The glue-in-place patch type repairs performance cannot be predicted and therefore are not-applicable to engineering design calculations as described in ASTM F1216.

- For the most part, the mainline lining is made from a CIPP (cured-in-place pipe) that includes a smooth thermoplastic film on the interior of the lining. These thermoplastic films are typically polypropylene, polyethylene and or polyurethane. Polyethylene and polypropylene resist adhesion, and ester grade polyurethane is not hydrolytically stable, which means the plastic film over time will dissolve. Without removing the thermoplastic film adhesion of the glued-in-place hat style patch becomes problematic.

- Fats, oils, and grease (F.O.G.) universally exists in a existing old sewer pipe, and most cured-in-place pipe-liner, inverted from manhole to manhole, has a lubricant applied to the liner film. The lubricant is added during installation to reduce friction as the liner tube is inverted. These lubricants prevent hat type patch connection seals from adequately bonding to a mainline lining.

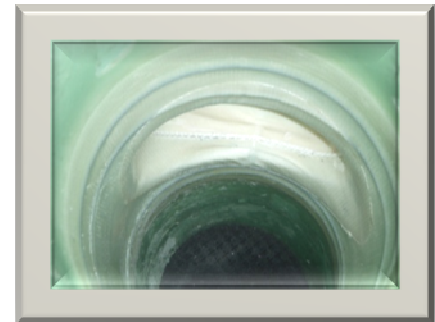
Figure 3: Structural Main/Lateral CIPP

An alternative CIPP connection seal solution is to provide a long-term, structural installation. To accomplish this, the connection seal must take the shape of the mainline pipe, by forming a cylindrical lining, and designed and constructed in accordance with parameters described in ASTM F1216 (Kiest & Gage 2009). The design parameters include: Refer to Fig 3

- Pipe Depth
- Pipe Diameter
- Water Level (above pipe crown)
- Soil Density
- Soil Modulus
- Liner Thickness
- Liner Flexural Modulus

Also in order for a CIPP connection seal to form a long-term watertight seal, the Main/Lateral CIPP must include swelling gasket seals as part of the installation. The connection seal, as described in ASTM F2561-06, must be designed for a minimum service life of 50-years and provide a non-leaking connection between a mainline pipe lining and a service connection pipe. Compression gasket sealing is a globally accepted practice for sealing new pipe joint connections, especially when used for underground applications such as sewer and water. The swelling gaskets form a seal against all pipe lining materials and are typically not affected by lubricants applied to CIPP or F.O.G found in sewers. (Kiest & Gage 2009).

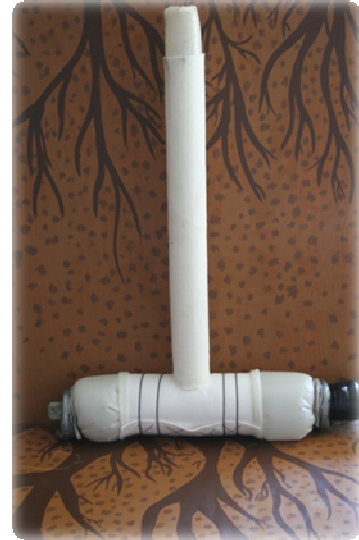
Figure 4: Lateral Lining

This process, described in ASTM F2561-06, incorporates the same full-circle structural lining and gasket sealing as used for CIPP connection sealing. The lateral lining tube however, extends several feet up into the lateral pipe. Installation is achieved by inserting the main/lateral lining assembly into the main pipe, robotically positioning and inverting the liner tube up the lateral pipe without access to or ending at a cleanout.

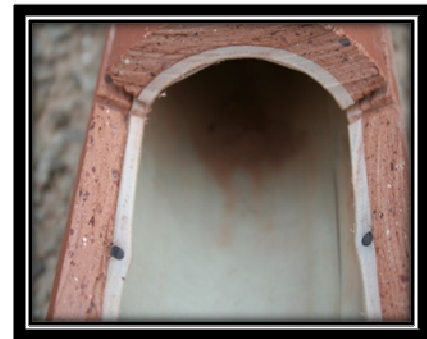
Figure 5: Lateral Lining

This process, described in ASTM F2561-06, incorporates the same full-circle, structural lining and gasket sealing as used for connection sealing to the property line. The lateral lining tube extends to a specified location on private property or to the building foundation. The liner is continuous in length or in cases when conditions prevent a continuous lining, two liners overlapping one onto the other may be used, provided swelling end seals are used (Refer to Fig. 5). In this case, the end of a lining tube includes a hydrophilic O-ring so when the second liner overlaps the first liner, the swelling gasket is positioned between the lining tubes forming a water-tight connection between the two overlapping linings. As with all of the other methods the swelling gaskets provide for the universal compression seal to the mainline lining. This process requires a clean-out to effectively clean the pipe, robotically position the liner assembly, control flow and reduce risk during liner insertion.
